## Section 5. Risk Assessment

### 5.7 Geological Hazards

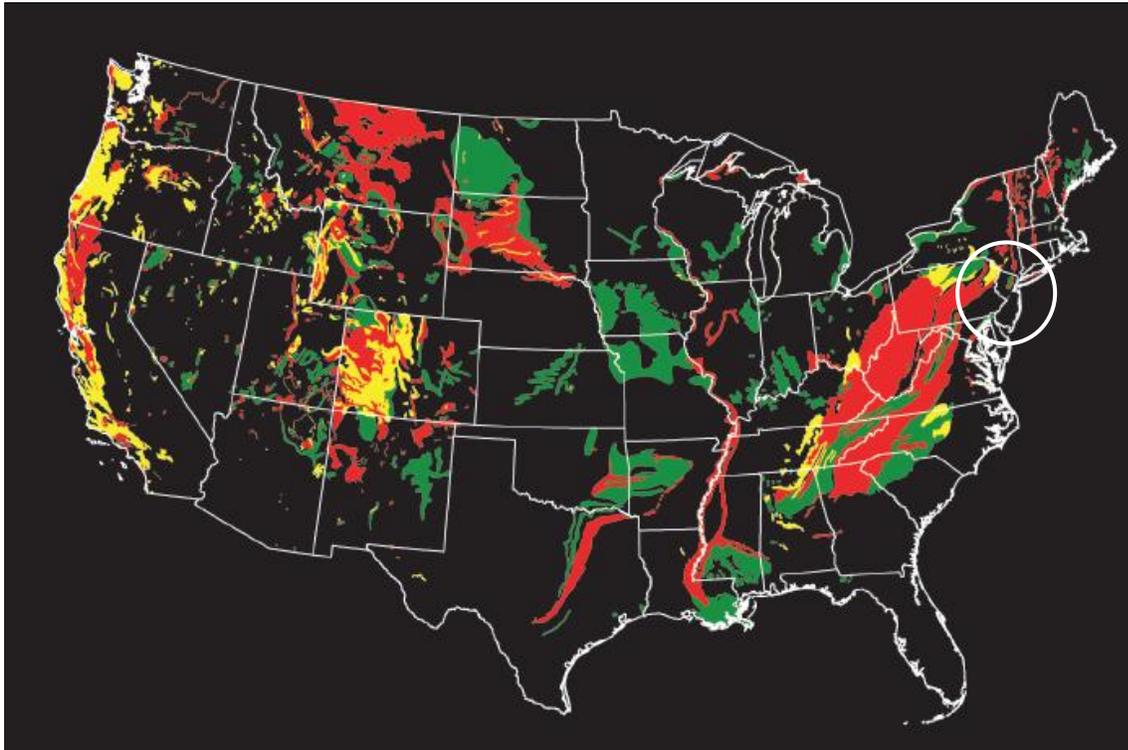
Figure 5.7-1. Landslide Potential of the Conterminous U.S

Note: Red areas have very high potential, yellow areas have high potential, and green areas have moderate potential. Landslides can and do occur in the black areas, but the potential is low. Map not to scale. Circle indicates the approximate location of New Jersey.

The entire United States experiences landslides, with 36 states having moderate to highly severe landslide hazards. Expansion of urban and recreational developments into hillside areas exposes more people to the threat of landslides each year. Figure 5.7-1 illustrates the potential for landslides in the United States

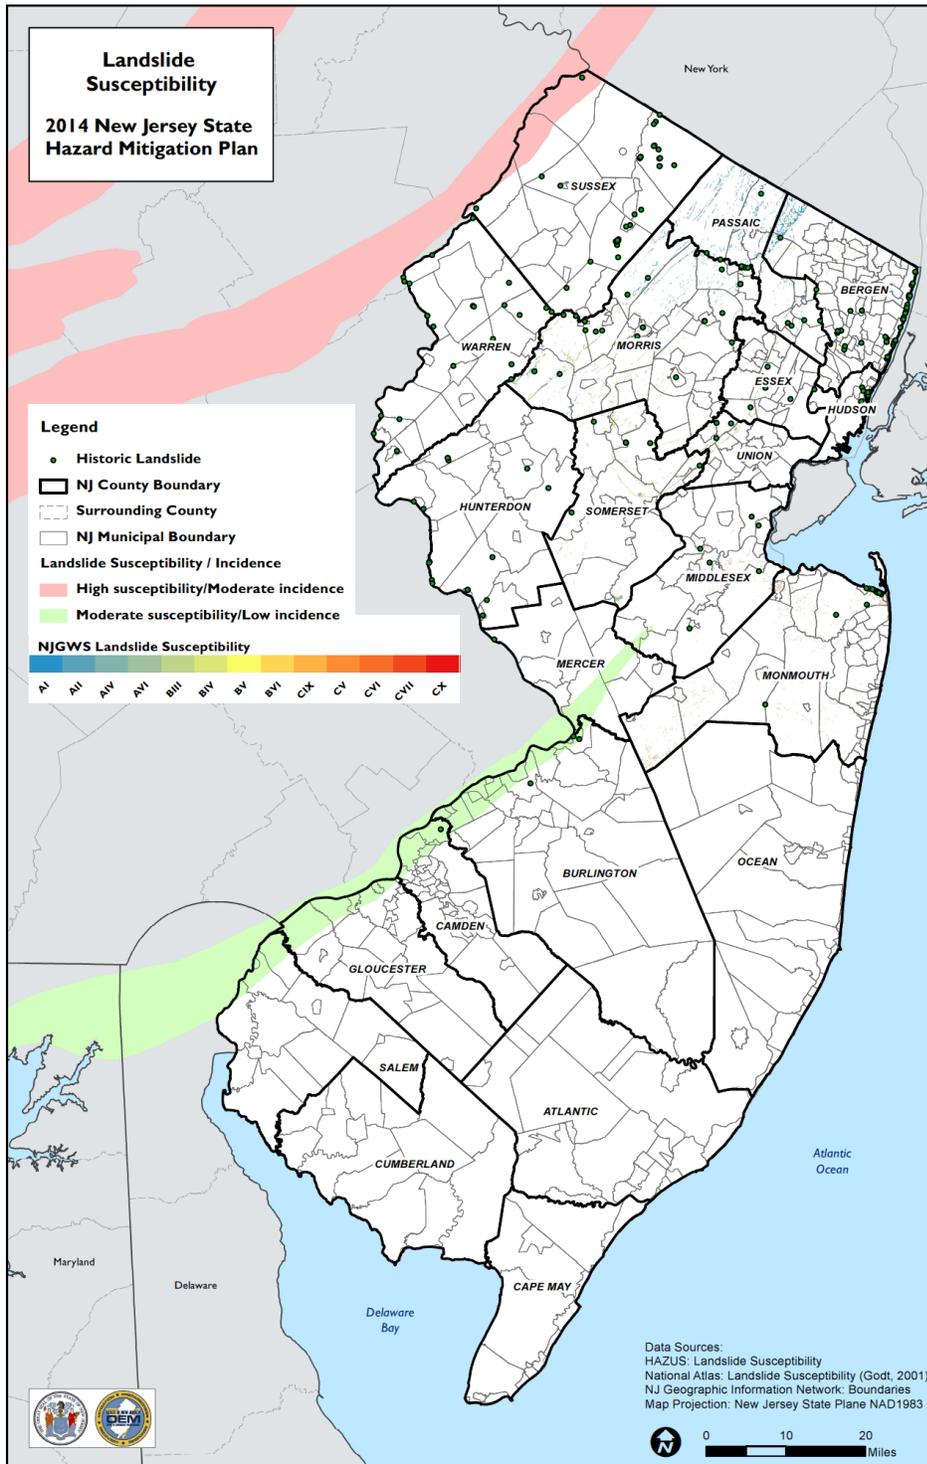
Figure 5.7-2. Landslide Susceptibility in New Jersey

Notes: Due to the scale of the map, the NJGWS landslide susceptible areas are difficult to see; refer to Appendix R for each county's map.

For the remainder of the State, the National Landslide Incidence and Susceptibility layer of the conterminous United States can be used to coarsely define the general landslide susceptible areas (Godt 2001). It is recognized that this data is highly generalized and is not suitable for local planning. According to Radbruch-Hall et al., the Landslide Incidence and Susceptibility Geographic Information System (GIS) layer from National Atlas:

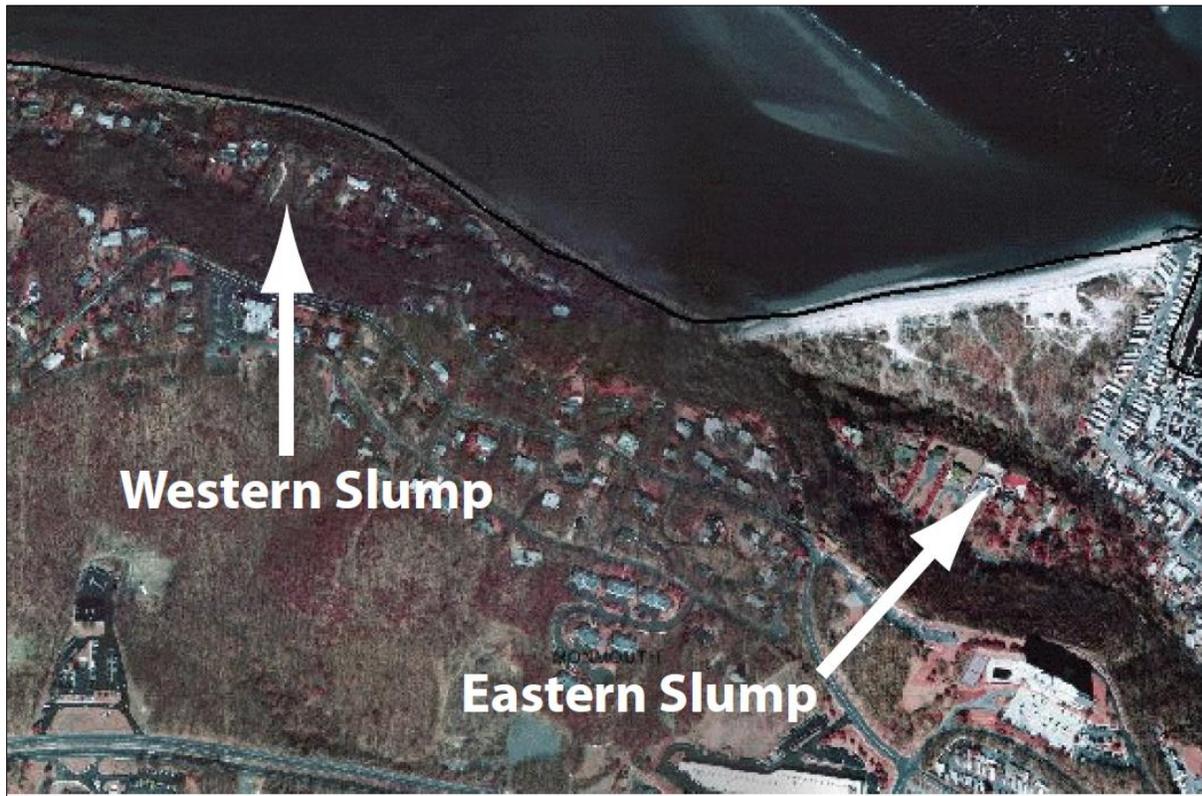
**Figure 5.7-3. Atlantic Highlands Slump Zone**

Located in the Sandy Hook Bay, the Atlantic Highlands Slump Zone has a long history of slumping that extends back a couple hundred years and continues today. Most of the older slumps in this region were caused by the Atlantic Ocean wave action when the Raritan Bay was open to the ocean hundreds of years ago. Today there are two active slump zones: the western slump block is 400 feet wide and 2,500 feet long, and the eastern slump is 450 feet wide and 1,400 feet long (Minard 1969). The eastern slump is the result of two large landslides in the past. The first slump included an entire mass; the second slump included a smaller section. Figure 5.7-3 illustrates the location and extent of the western and eastern slump zones.

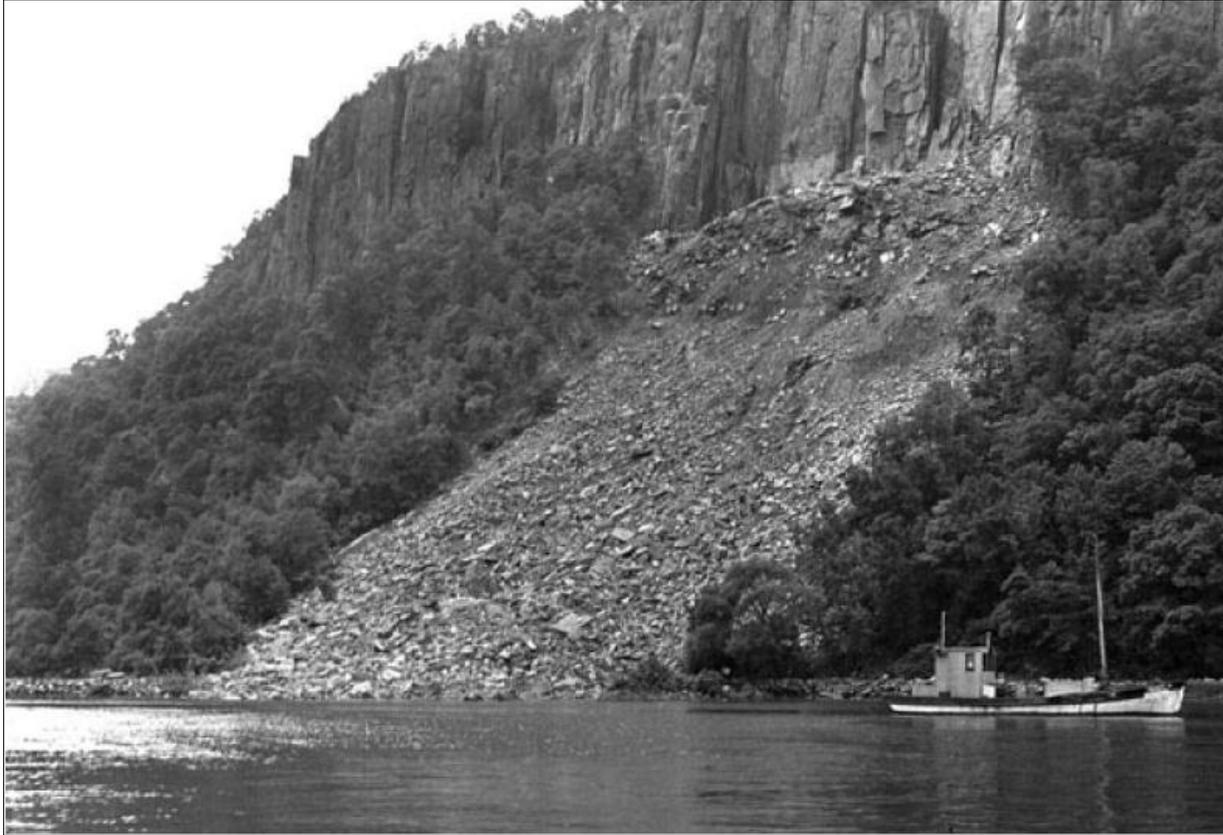
Figure 5.7-4. Rockslide in the Palisades in 1938

In addition to this region, one of the most active landslide areas is the Palisades along the Hudson River. In this region, large rockfalls and rockslides occur along the high cliffs bordering the Hudson River. These landslides are most common in the winter and spring months after freeze-thaw cycles occur and loosen pieces of rock along joints and fractures. Surface water also seeps into joints and cracks along the rock, increasing the weight of the rocks and causing the expansion of joints when it freezes, thus prying blocks away from the main cliff (Hansen 1995). Figure 5.7-4 illustrates a significant rockslide along a section of the Palisades.

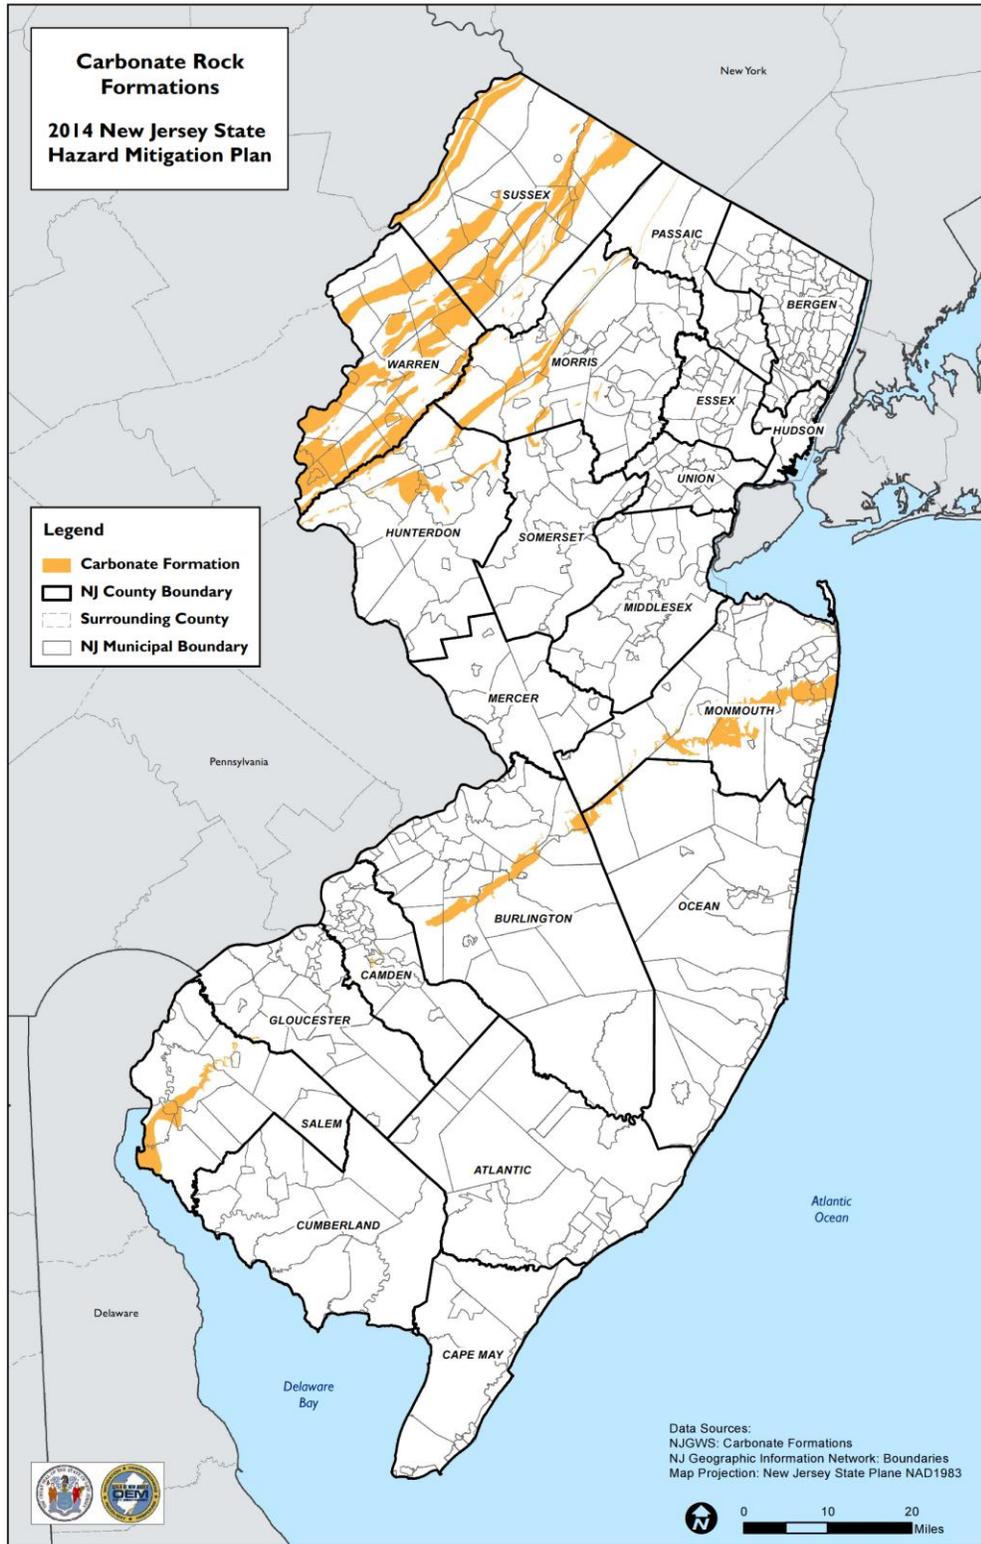
Figure 5.7-7. Carbonate Rock Regions of New Jersey

Figure 5.7-7 illustrates the locations of carbonate-bearing geologic formations of New Jersey. These formations are areas of potential natural subsidence. These geologic units contain a high enough percentage of carbonate minerals such as calcite and/or dolomite for karst features such as sinkholes to form. Some of these units may be more prone to sinkhole development than others due to a greater carbonate content in the rock. Although not every unit listed has documented sinkholes, all are susceptible to dissolution by groundwater so various karst features, including sinkholes, may be found on any of these units.

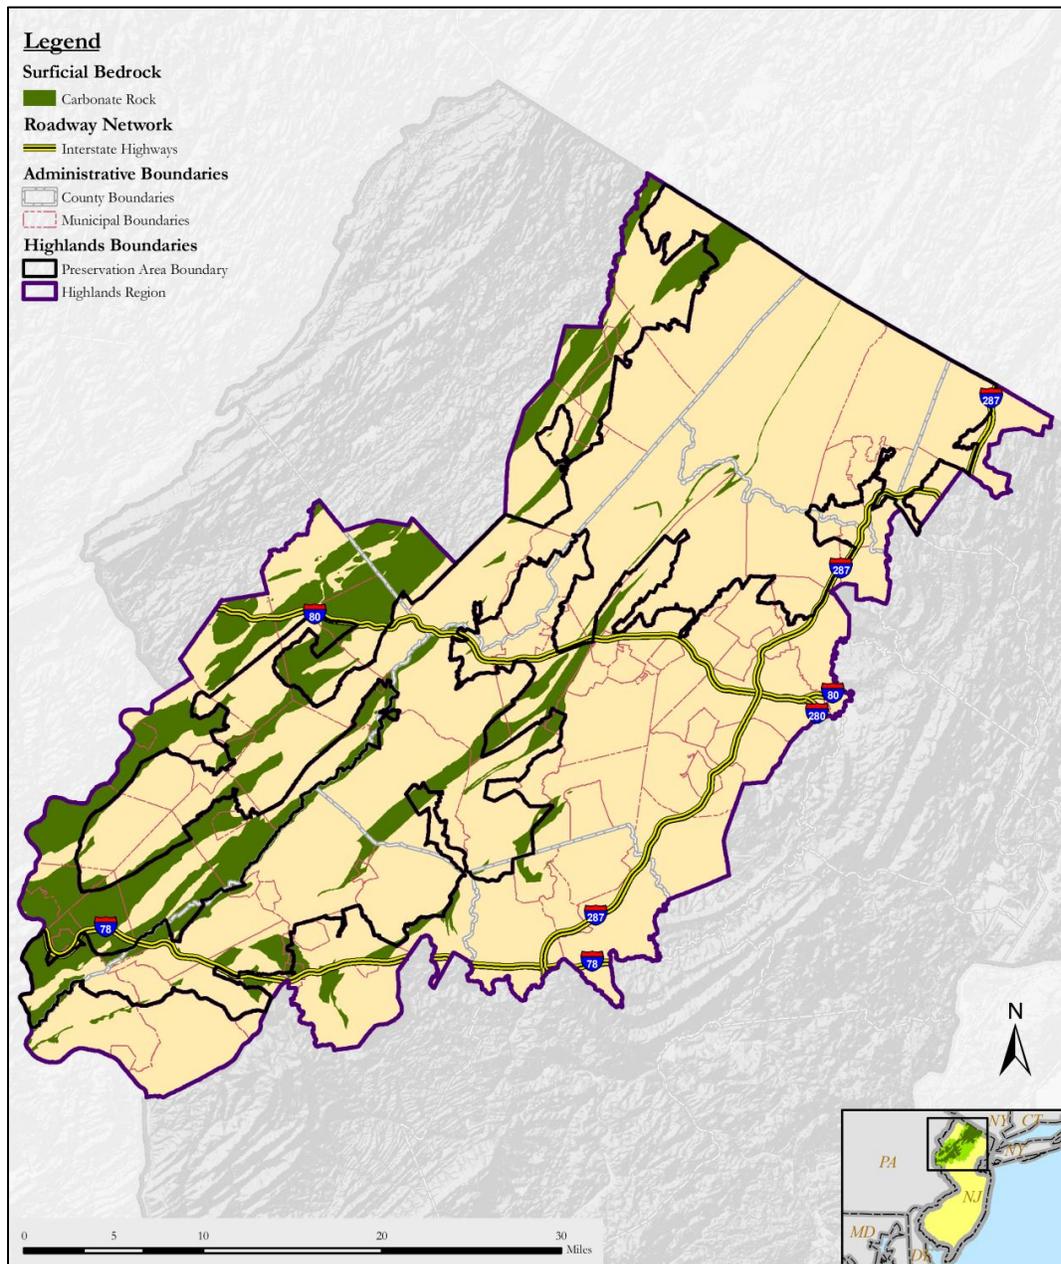
Figure 5.7-8. Carbonate Rock in the New Jersey Highlands

Substantial areas of the New Jersey Highlands are underlain by carbonate rocks (Figure 5.7-8). These rock formations, consisting primarily of limestone, dolomite, and marble, have unique characteristics that require responses to both the policy level and in specific technical guidance to municipalities. According to the NJDEP, 59 of the 88 municipalities within the Highlands region contain carbonate rocks. Eleven of these municipalities are in Hunterdon County. Fourteen municipalities are in Morris County. Four municipalities are in Passaic County, three are in Somerset. Eight municipalities are in Sussex and 19 are in Warren. Far from being an isolated geologic condition, the widespread presence of carbonate rocks in the regulated area indicates that their presence is a matter of regional concern.

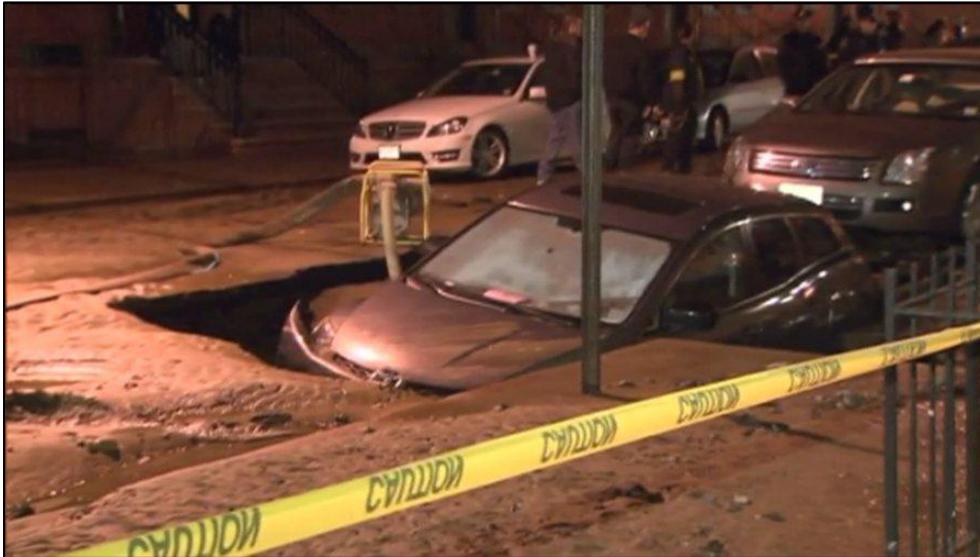
Figure 5.7-10. March 2013 Hoboken Sinkhole

Also in 2013, a sinkhole caused several water main breaks in Hoboken and prompted boil water advisories across the City. In addition to causing several water main breaks, the sinkhole swallowed a car. The sinkhole was caused by a construction crew that accidentally struck a water main, washing out loose subsurface fill and also leading to several sinkholes and additional water main breaks throughout the City. The original sinkhole occurred at approximately 3 a.m. on March 28, 2013 (Gilliam 2013). Figure 5.7-10 shows the Hoboken sinkhole from March 2013.
